# Annual MS4 Report – FY25

## VSMP Permit No. VA0088595

Submitted by:  
Prince William County  
Department of Public Works

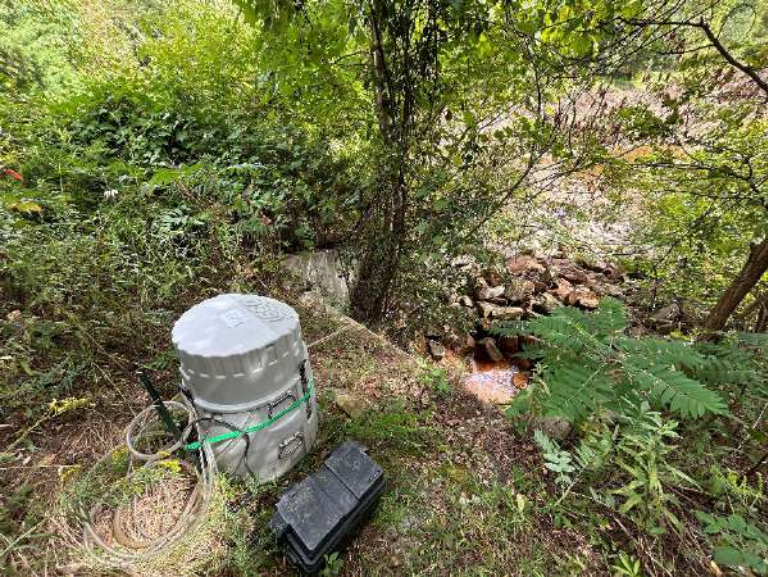
| | <p><b>Site:</b> Dale City Station</p> <hr/> <p><b>Photo:</b> 1</p> <hr/> <p><b>Date:</b> 9/16/2024</p> <hr/> <p><b>Description:</b> Dale City sampler set up overview.</p> |

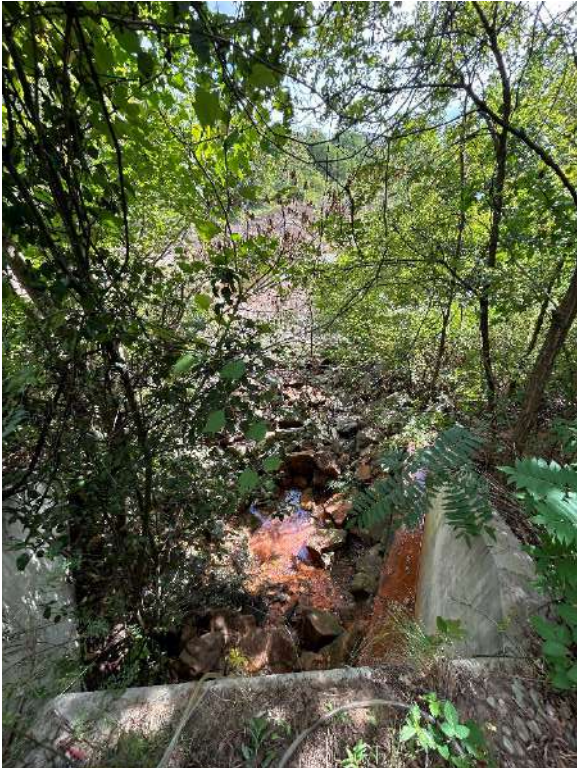
| | <p><b>Site:</b> Dale City Station</p> <hr/> <p><b>Photo:</b> 2</p> <hr/> <p><b>Date:</b> 9/16/2024</p> <hr/> <p><b>Description:</b> Dale City outfall, downstream. Note Iron-oxidizing bacteria growth staining rip rap downstream.</p> |

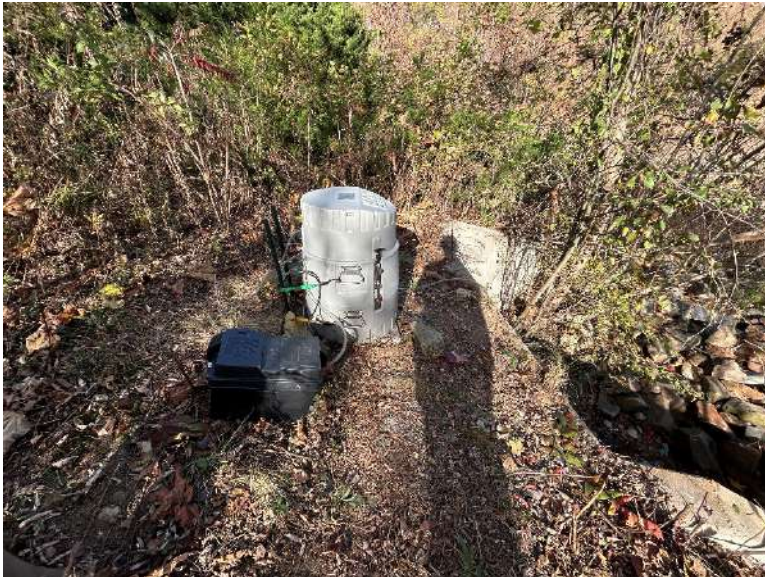
**Photo:** 1

**Description:** Dale City sampler set up overview.

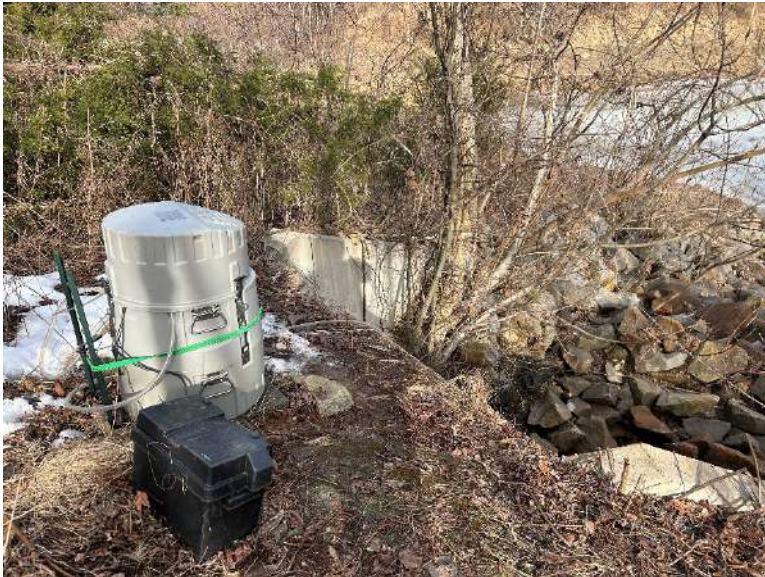
**Photo:** 1

**Description:** Dale City sampler set up overview.

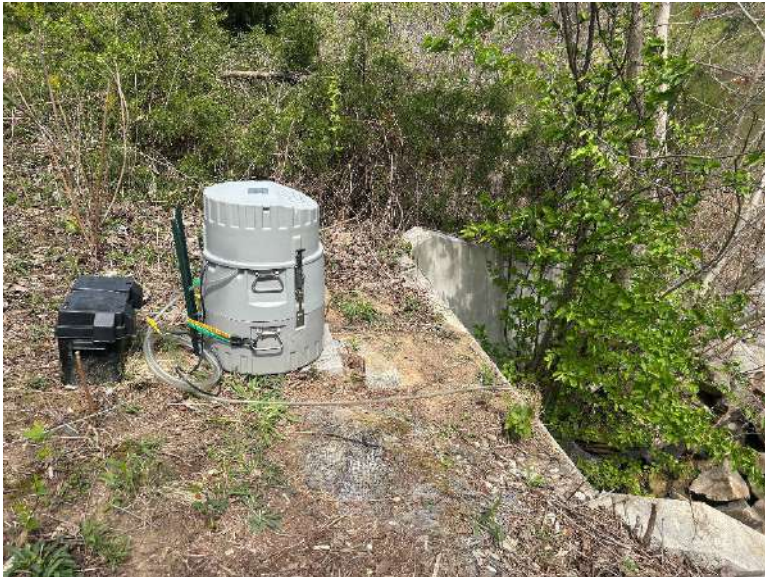
**Photo:** 1

**Description:** Dale City sampler set up overview.

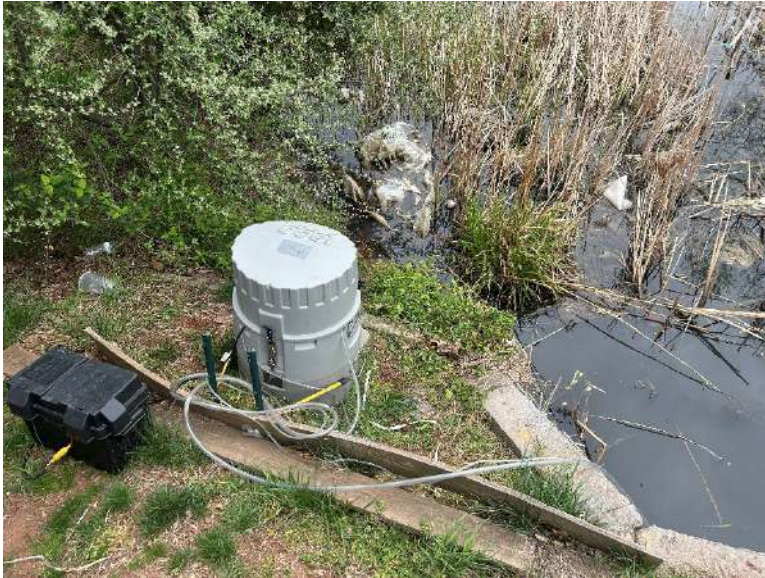
**Photo:** 3

**Description:** Manassas sampler set up overview.
